HUMAN-PLANTED ALDER TREES AS A PROTECTION AGAINST DEBRIS FLOWS (A DENDROCHRONOLOGICAL STUDY FROM THE MOXI BASIN, SOUTHWESTERN CHINA)

Abstract: Large debris flows have destroyed the infrastructure and caused the death of people living in the Moxi Basin (Sichuan Province, Southwestern China). Inhabitants of the Moxi Basin live on the flat surfaces of debris-flow fans, which are also attractive for farming. During the monsoon season debris flows are being formed above the fans. Debris flows can destroy the houses of any people living within the fan surfaces. In order to prevent the adverse effects of flows, people plant alder trees (*Alnus nepalensis*) at the mouths of debris flow gullies running above debris flow fans. Alders are able to capture the debris transported during flow events. Trees are well adapted to surviving in conditions of environmental stress connected with abrupt transport and deposition of sediment from debris flows. Numerous wounds, tilting and bending of alder trees caused by debris flows only very rarely cause the death of trees. By dating scars and dating the time of alder tilting (through the analysis of annual rings), we have determined the frequency of deb

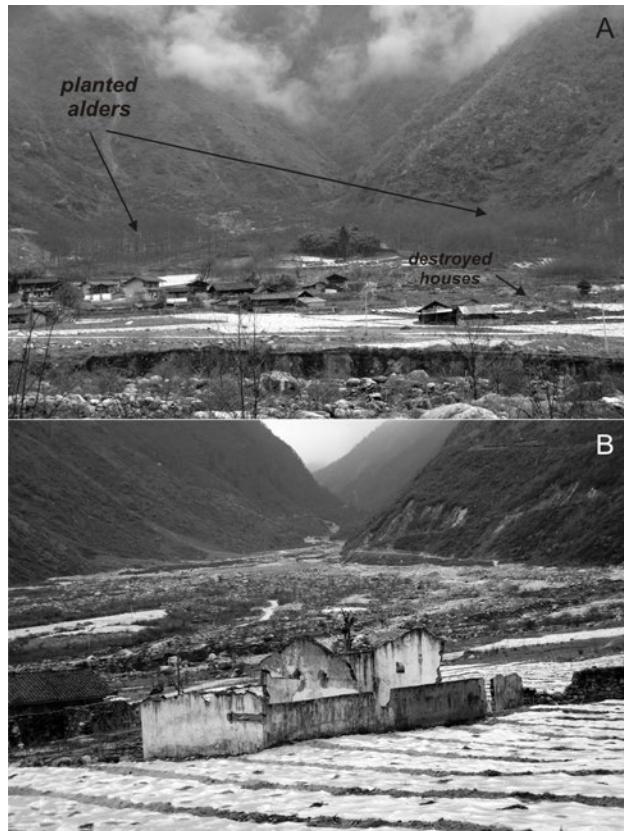
Fig. 1. The debris flow fan under study, (A) – the village is located on the debris flow fan and the planted alders are marked with arrows, (B) – one of the houses destroyed by debris flows.

The people living in the mountainous areas of Sichuan Province often occupy small debris-flow fans located at the foot of gullies formed in loose moraine sediments (Fig. 1A). The debris flows which develop in these areas destroy houses and threaten human lives (Fig. 1B). Local people plant *Alnus nepalensis* saplings on fan surfaces in order to protect their villages from destruction by debris flows (Fig. 2A). Alder trees growing within the fans are being wounded and tilted by the debris transported during flows. At the same time, the trees slow the movement of debris flows and capture a portion of the debris, thus protecting people and their houses (Fig. 2B). This creates an opportunity for carrying out dendrochronological studies on human-planted alder specimens.

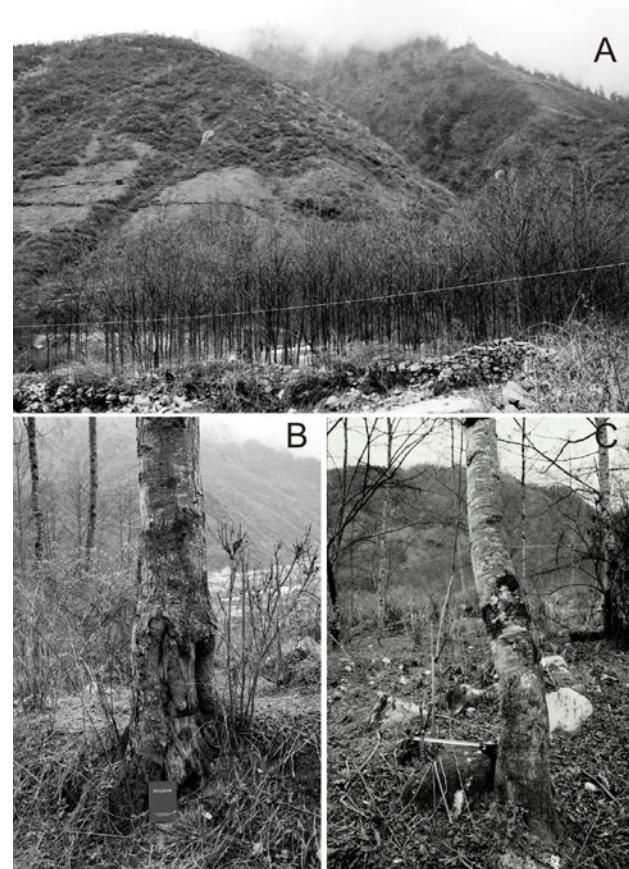
Fig. 2. Alders growing on fan under study, (A) – an alder plantation, (B) – an alder specimen wounded by a debris flow, (C) – an alder specimen tilted by a debris flow.

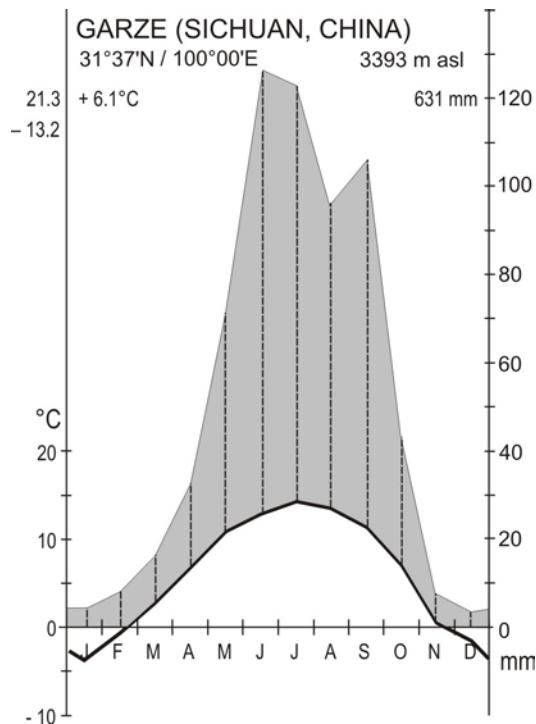
Fig. 4. Climatic diagram of the Garze meteorological station (40 km to the north of the area under study).

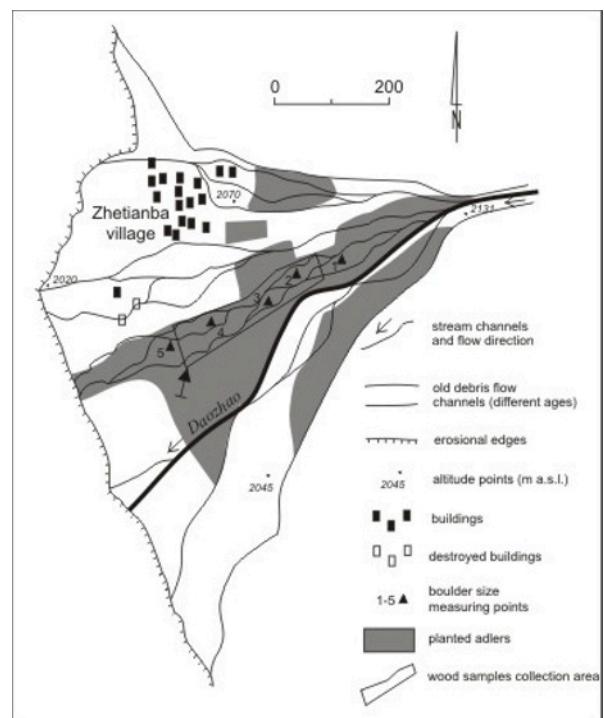
Fig. 5. Geomorphic sketch of the alluvial fan analyzed; the arrow indicates the wood sample collection area.

Trees are growing within an area of 0.09 km^2 . For the purposes of conducting a detailed study, we chose an area of 0.02 km^2 (Fig. 5). In this area, we counted the trees which captured debris material. We assumed that alders were able to capture debris transported through the fan if their stems were buried under sediment and, additionally, at least two boulders were lying within a distance of less than 1 m from the stem. This attempt enabled us, in all probability, to determine the minimal amount of trees which capture coarse debris during debris-flow events. The presence of one boulder near a tree and the presence of more than one boulder within a distance of more than 1 m from a tree did not, in my opinion, provide sufficient proof of the role of tree-stems in capturing debris.

We decided to measure only the 15 biggest boulders at each of the 5 selected locations (measuring points – **Fig. 5**).

We took cores from 30 tilted and wounded alder trees growing on the debris flow fan (**Fig. 5**). From each tree, we collected at least 3 cores at breast height. One core was always collected from the middle of the wound/scar, the second – 5 cm above the wound/scar and the third, perpendicular to the wound/scar (**Fig. 7**). In the case of some trees, in which the three cores we had collected earlier were broken or damaged due to uneven wood density, we collected additional cores 5 cm below the wound/scar. 114 cores in total were collected from trees growing on the debris flow fan under study. Ring widths were measured in all the collected cores using the LinTab measuring system and TSAPWin Professional 4.65 software. Cores collected from individual trees were cross-dated for wound dating. We used visual comparison and

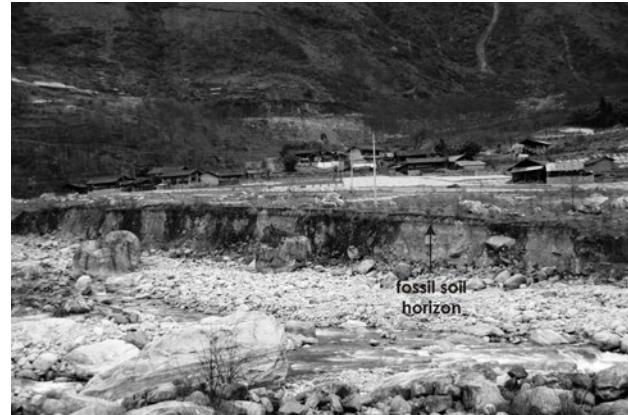
Fig. 6. The horizon of fossil soil as evidence for the occurrence of at least a few stages of debris deposition within the fan under study.

while the debris fan is located between 2020 and 2131 m a.s.l. (Fig. 3). The gully is c. 4 km long, with an average slope of 31.5%. The debris-flow fan under study is 731 m long and 1100 m wide at its broadest point. Its average inclination is 10.1%. The total area of the fan is 0.34 km². A different generation of debris flow tracks are clearly visible in the relief of the investigated alluvial fan (Fig. 5). The debris flow sediments are up to 20 m thick. The debris fan is being undercut by the Yajiaogeng River. Within the river bank, in the cross-profile, debris accumulated during different phases of gully activity and fan formation can be seen. These are separated by soil horizons (Fig. 6).

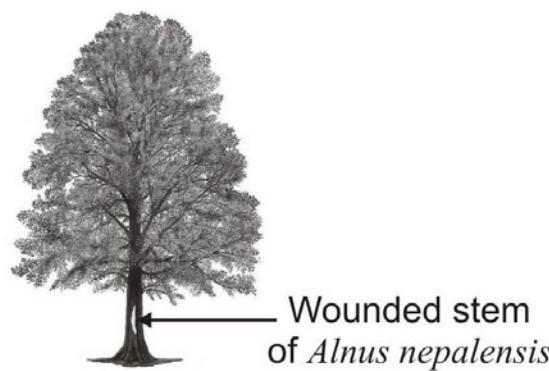
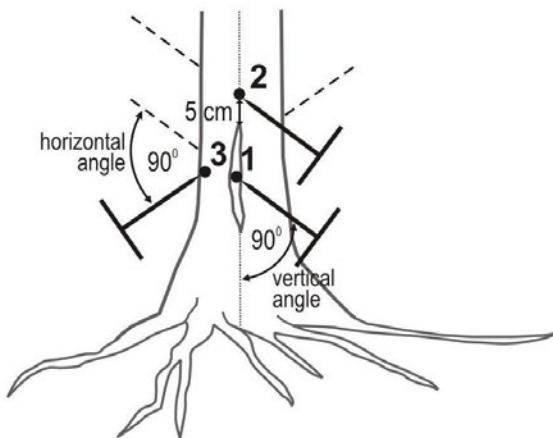
Fig. 7. The method of taking samples (cores) from alder stems, (1) – a core extracted from the middle of the scar, (2) – a core extracted 5 cm above a scar, (3) – a core extracted perpendicularly to a scar.

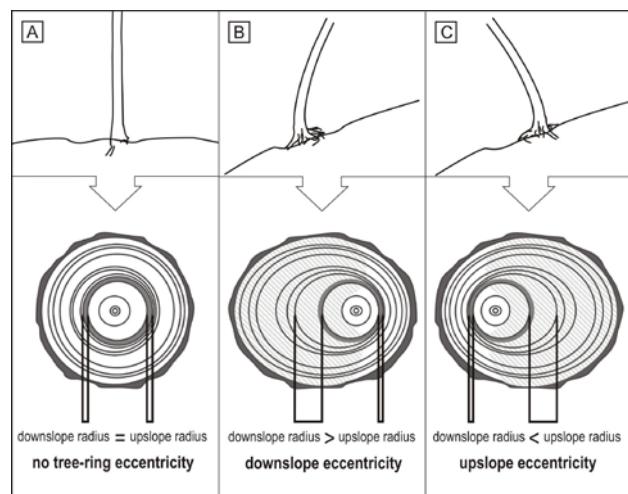
Fig. 8. Tree-ring eccentricity in relation to the direction of stem tilting, (A) – no tilting, (B) – up-slope tilting, (C) – down-slope tilting.

Eccentricity index calculation was applied to the date tilting of alder trees. The method has been described in detail by Malik and Wistuba (2012). It is based on the assumption that tilted trees (deformed by a debris flow event) produce wider rings on one side of the stem and narrower rings on the other – i.e. that eccentric growth occurs (**Fig. 8**). The first year of eccentric growth directly dates an episode of tree tilting and indirectly, debris flow occurrence. Sometimes eccentricity occurs more than once in one tree ring curve, which means that the tree was tilted more than once.

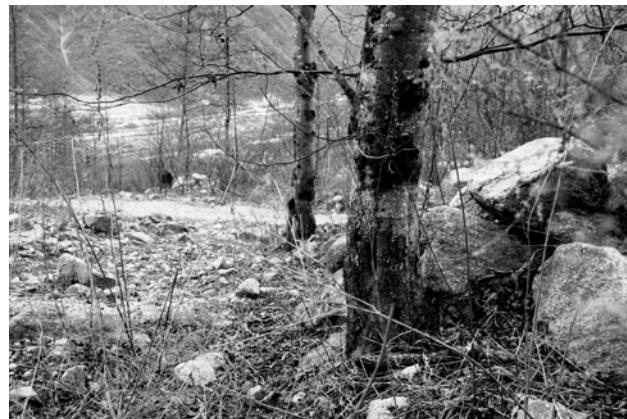
Fig. 9. Boulders captured by the stem of alder tree during a debris flow event.

It was found that 24% of analysed alder trees had captured coarse debris during past flow events (**Fig. 9**). The diameter of boulders rapidly decreases in the alder forest along the debris flow tracks. In the upper part of the fan, the average diameter of the rock particles reaches 145 cm (measuring point 1), whereas in the central and lower parts it only reaches 40-30 cm (points 4-5); (**Table 1**).
